REPORT OF AIRCRAFT ACCIDENT

44-9-19-38

(1) Place Will Rogers Field, Oklahoma (2) Date 19 September 1943 (3) Time 1631 CWT  
 AIRCRAFT: (4) Type and model A-20-G-10-DO (5) A. F. No. 42-54152 (6) Station Lake Charles Army Air Base, La. Chas., La.  
 Organization: (7) III Bomb Cd Third AF 416th Bomb (L) 670th Bomb (L) (Group) (Squadron)

(56) Nature of accident Landing Accident - Ship overrun runway and nosed over - Emergency air brake was used but failed to stop ship

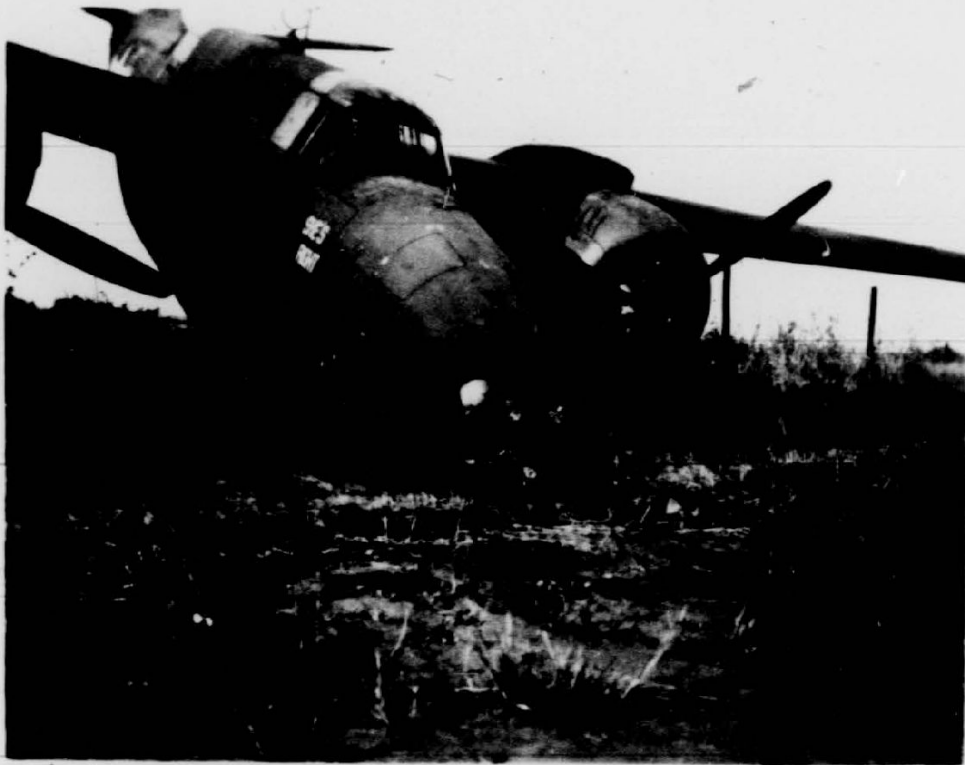
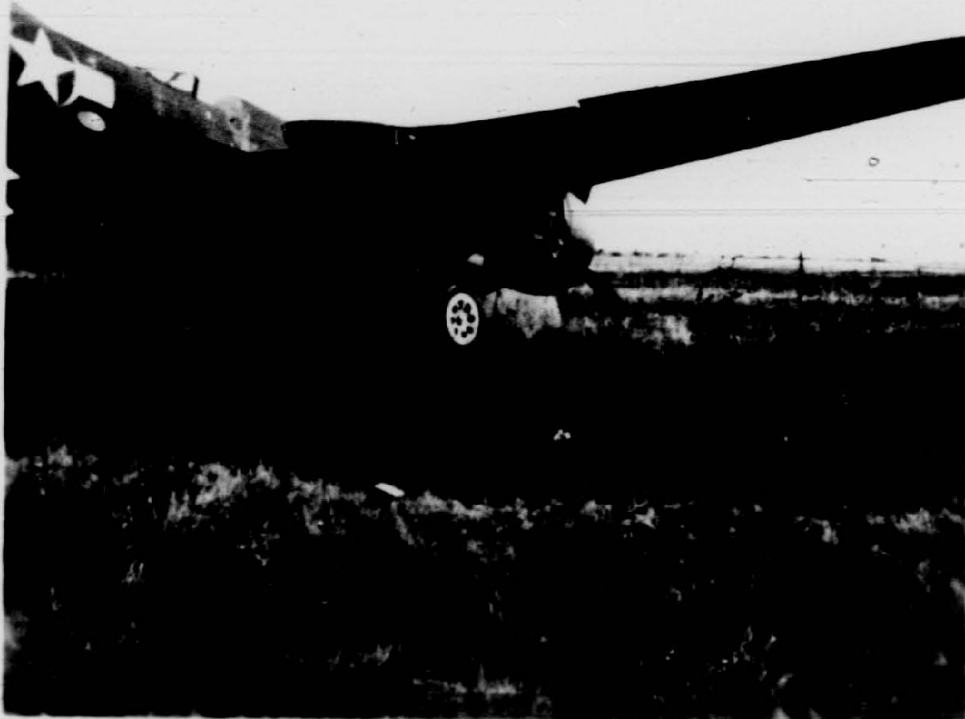
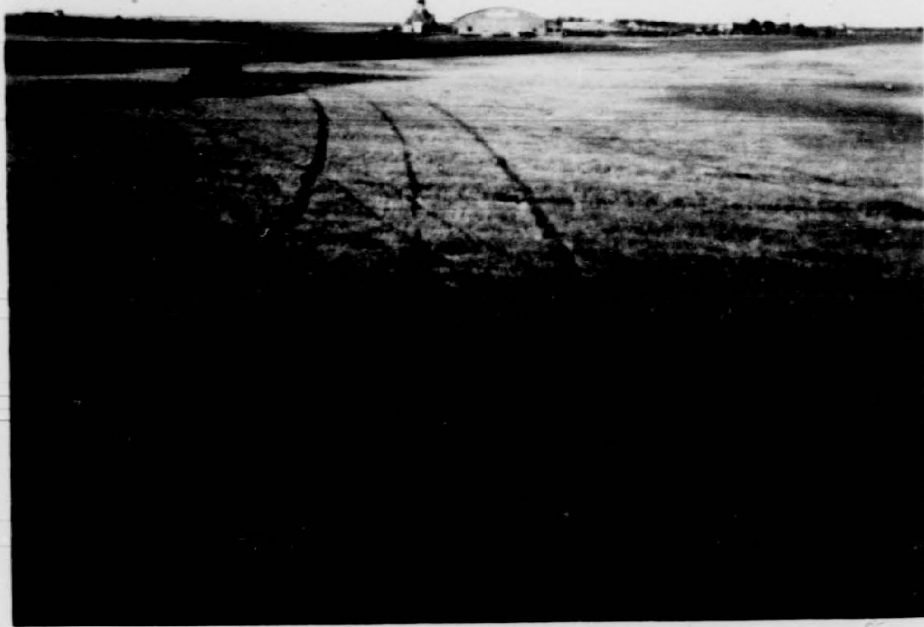
- a. The nose wheel assembly and cover door are completely sheared off. (This occurred just as the plane came to a full stop).
- b. Three of the six propeller blades are bent.
- c. Left tire blown out.
- d. Forward lower nose section damaged and front end of bomb-bay doors torn.

On viewing the accident it appeared that the airplane had crossed a ditch approximately 15 Feet wide and 2½ Feet deep. The nose wheel was apparently sheared off on hitting the far side of the ditch. The airplane had stopped on the far side of the ditch after tearing down part of the fence which borders the south side of the field.

The engines were cut and fully stopped before we hit. One blade of the left prop. was damaged and two blades of the right. The nose stout was torn completely off. The left tire was also blown out. The nose and bomb bay doors were damaged, but the fuselage was not buckled. There was no hydraulic pressure shown on the gauge. The ditch was about 15 feet wide and four feet deep.

It is recommended that a complete check list be prepared and requirements be made that it be followed by all pilots before entering any combat type aircraft for a proposed flight. It is further suggested that a check of the hydraulic fluid supply be included in this visual inspection. Besides providing an opportunity for the pilots to "know" their ships more thoroughly, a check of this kind will start them "flying" before they enter the cockpit.
